RICS **HomeBuyer** Report...

Example of Homebuyer Report

Date of inspection

18 June 2018

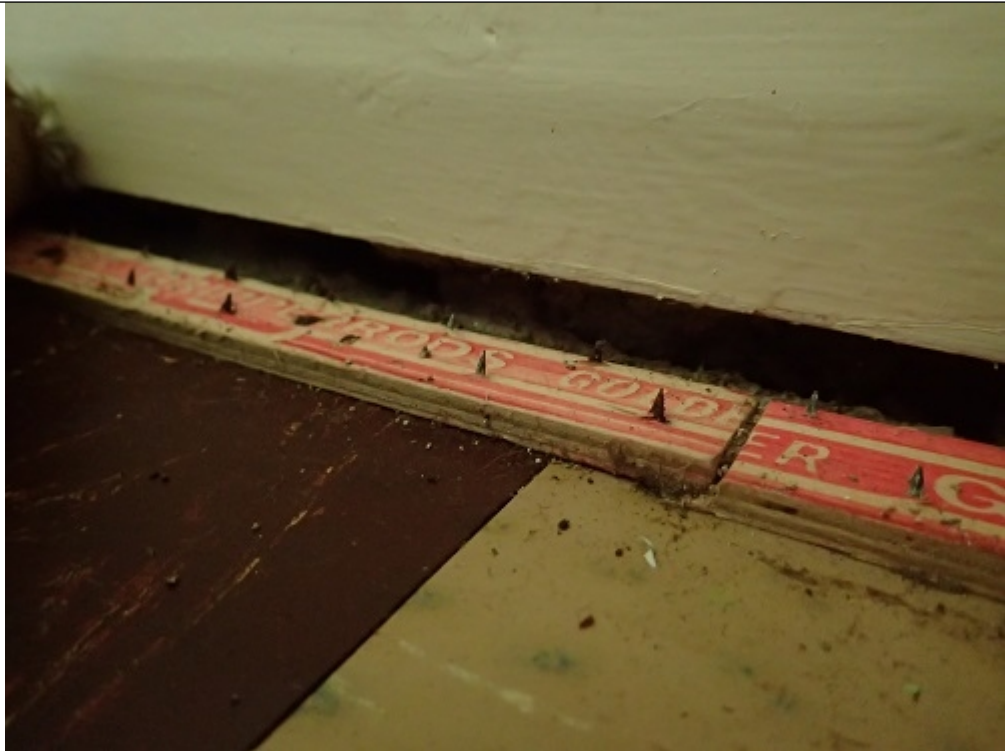
Significant distortion and dishing of the floors was noted in the dining room area. Evidence of cracking to the floor slab was noted in the sitting room area.

Concrete floor slab dropped and distorted.

Prior to exchange of contracts, we would recommend carpets are lifted and estimates obtained to repair the floors. Works required may include breaking up the existing floor slab and re-laying this on a sound base. Works of this type will be expensive and we would recommend you obtain estimates prior to legal commitment to purchase.

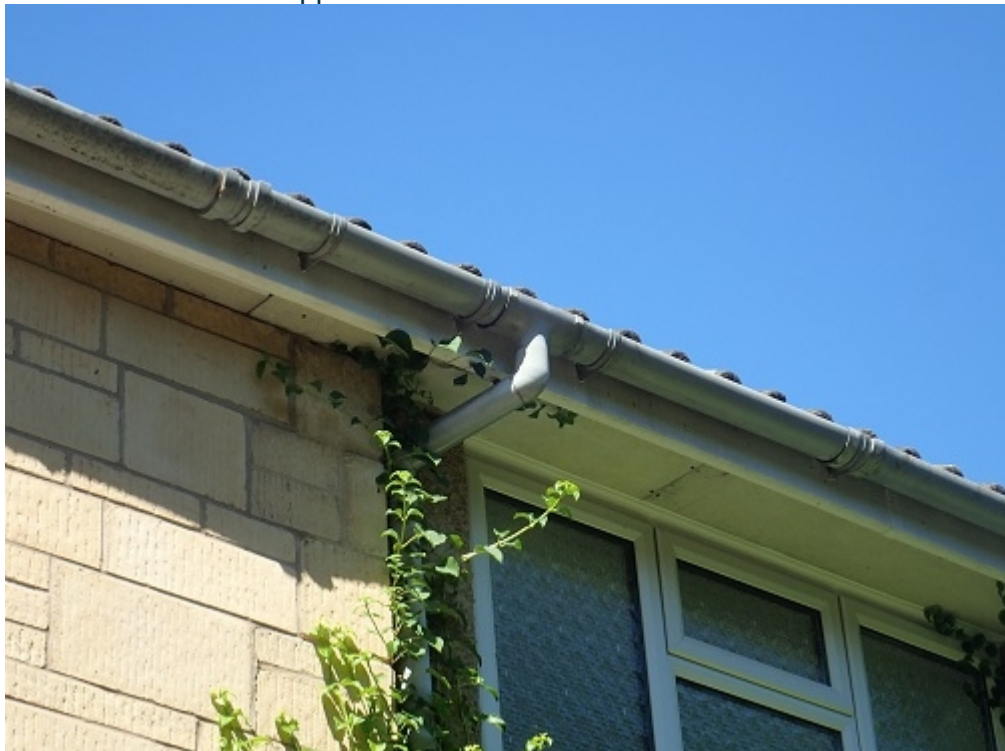
E8 Other joinery and finishes	<p>Fascia boards appeared sound.</p> <p>The soffits (undersides) are of a grey sheet material which may contain asbestos. Asbestos is a health hazard and no abrasive techniques or other actions should be carried out on this material which may release fibres.</p> <p>The grey sheet material at the underside of the tiles eaves overhang is also likely to contain asbestos.</p> <p>Condition rating 1</p>	1

Grey soffit boards may contain asbestos.

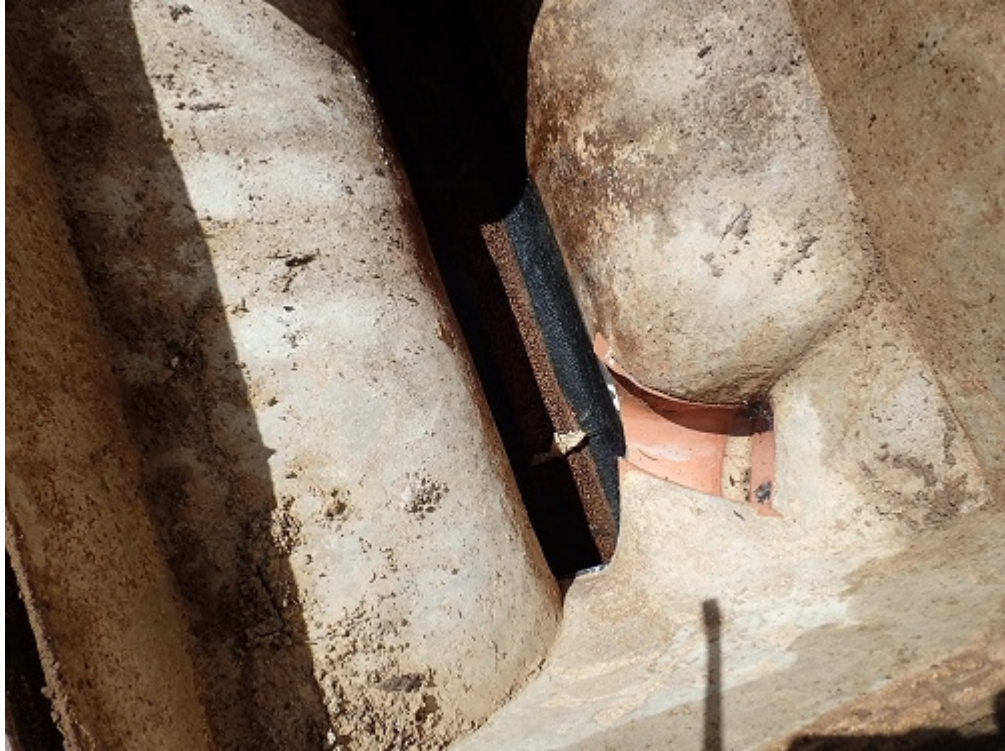
The manhole to the front was lifted. Drain runs are of a black fibre material. This appears relatively recent. The drain runs may have been re-lined and solicitors should make enquiries to confirm if any previous drainage repairs or problems have occurred.

Older pitch fibre black drain pipes are prone to distort, collapse and cause problems to drain runs. If no information is forthcoming from the solicitors we would recommend a specialist drainage contractor is instructed to inspect drain runs and report thereon prior to exchange of contracts.

Black fibre drain run.

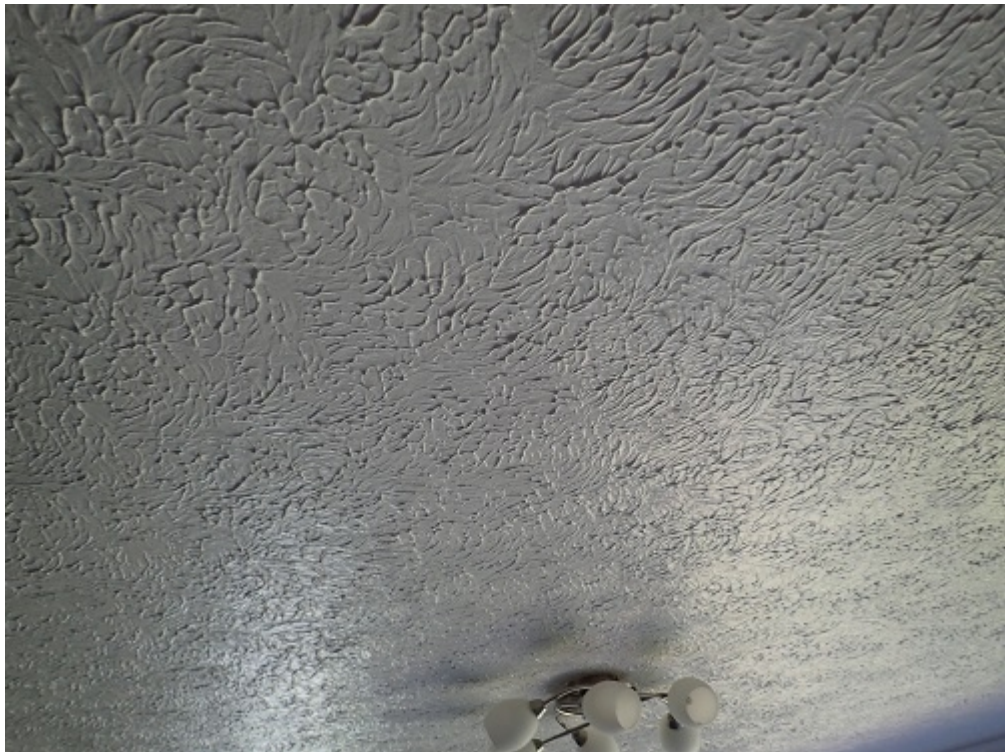
The only way to confirm or refute the presence of asbestos is to have the product sampled under laboratory conditions.

Artex may contain asbestos.

Should any future repairs to the artex be required this should be carried out by a contractor familiar with this type of work.

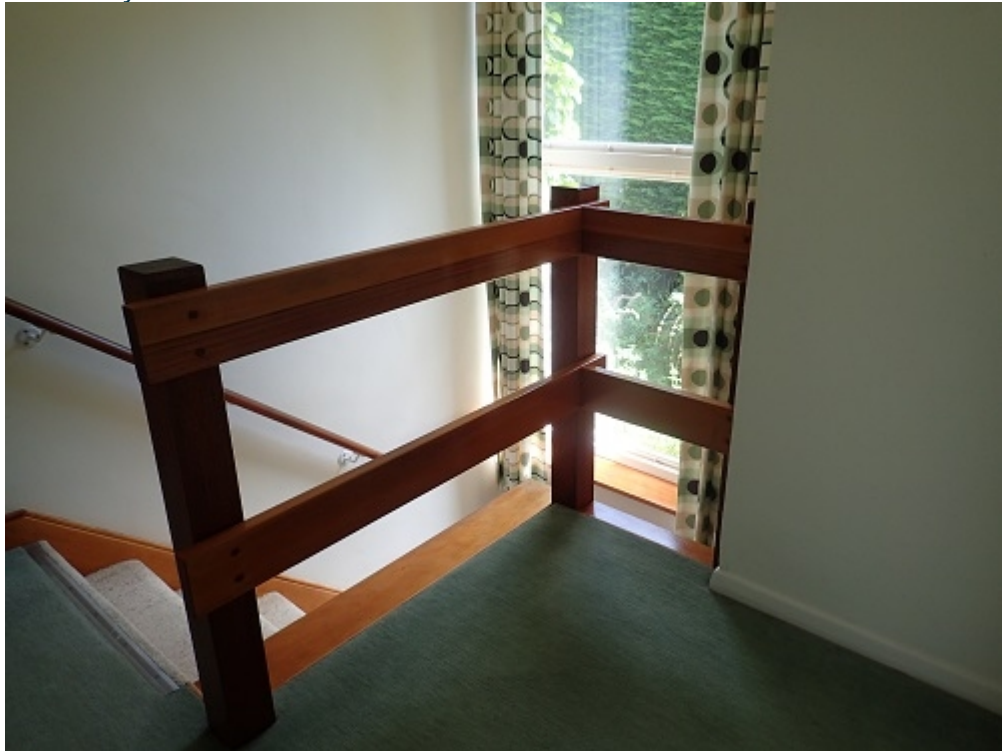
Open tread and handrail to staircase.

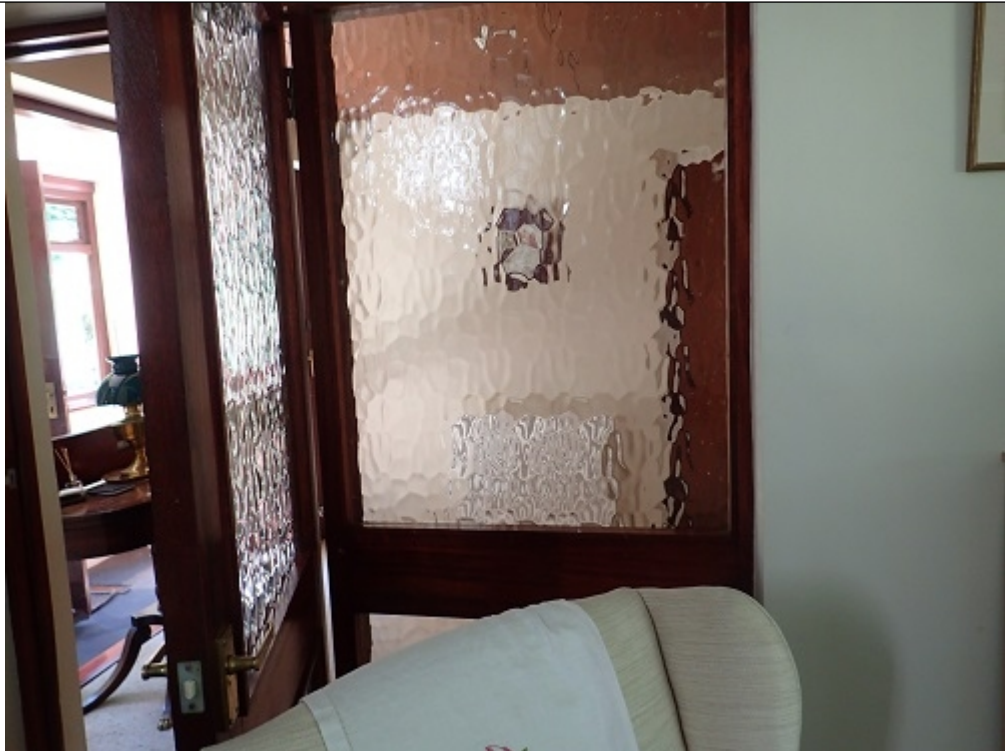
Internal glazed panels.

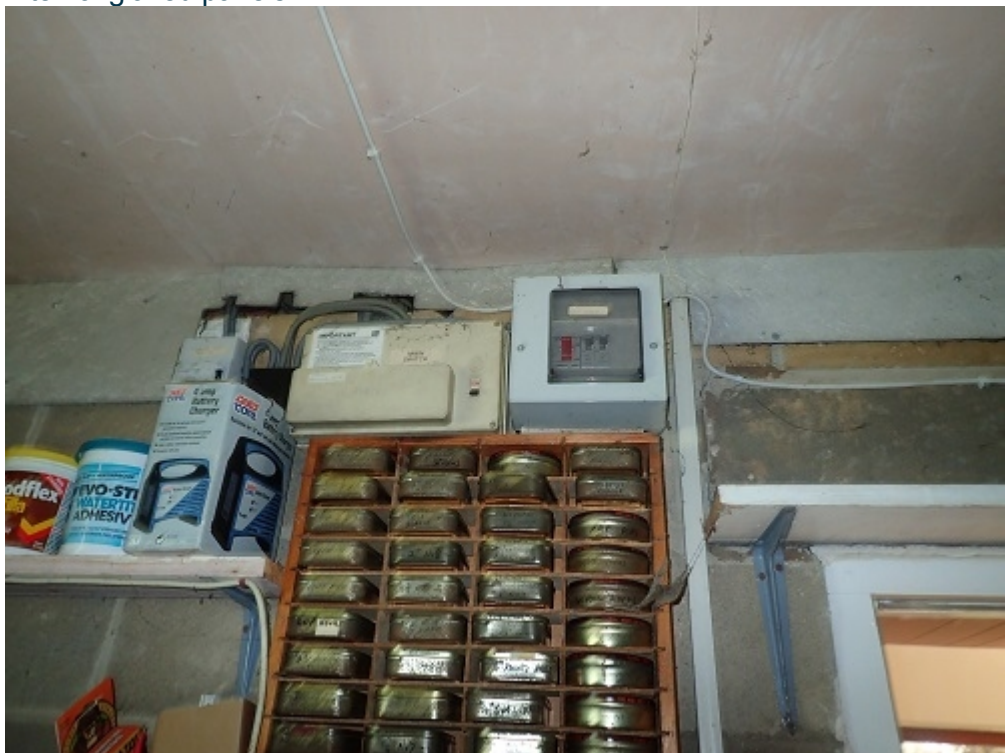
At high level, on the wall between the garage and house sections of asbestos cement sheeting were noted. The material lining the personal door between the garage residential accommodation may also contain asbestos.

Grey sheets and door lining to garage may contain asbestos

Various materials were noted within the building which are likely to contain asbestos. We would recommend a specialist firm is instructed to provide estimates to remove asbestos in the garage area and test suspect materials. Results of this inspection should be made available to you prior to exchange of contracts. Estimates for any removal works should also be obtained at this time.

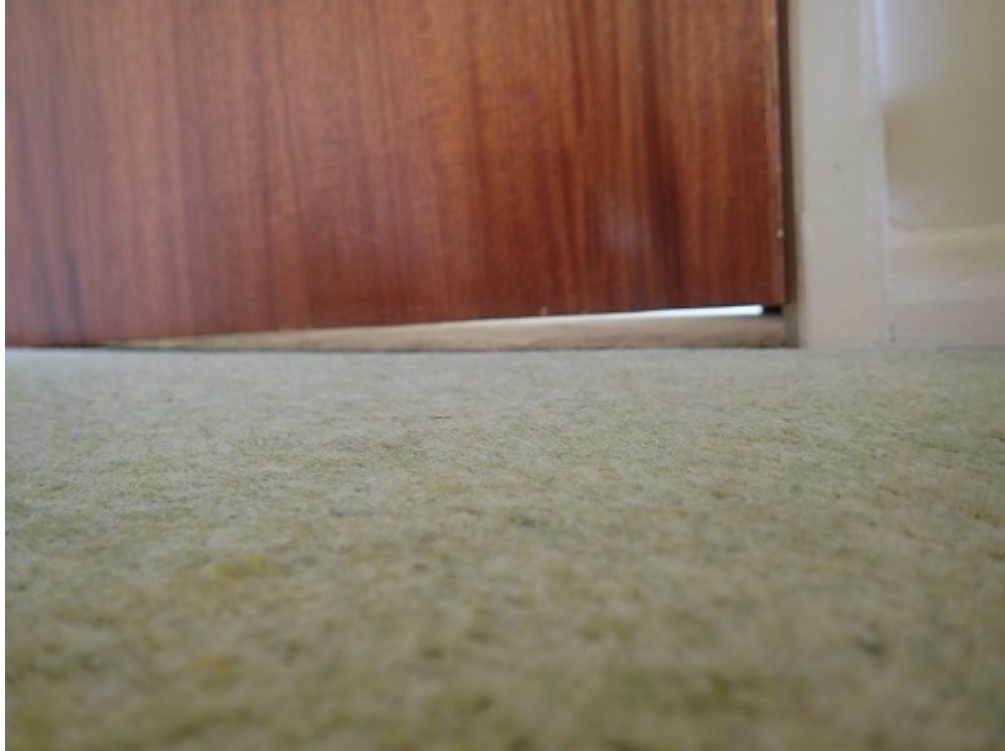
The wall between the dining room and sitting room area showed sign of past distortion. This was evidenced by distortion of the door frame. It is likely that this wall has suffered structural movement when the floor slab distortion occurred. No sign of recent damage or distortion was seen.

Past movement was noted to the wall between the dining room and sitting room. No signs of recent movement were seen.

Floor slab and wall between dining room and sitting room dropped and distorted.

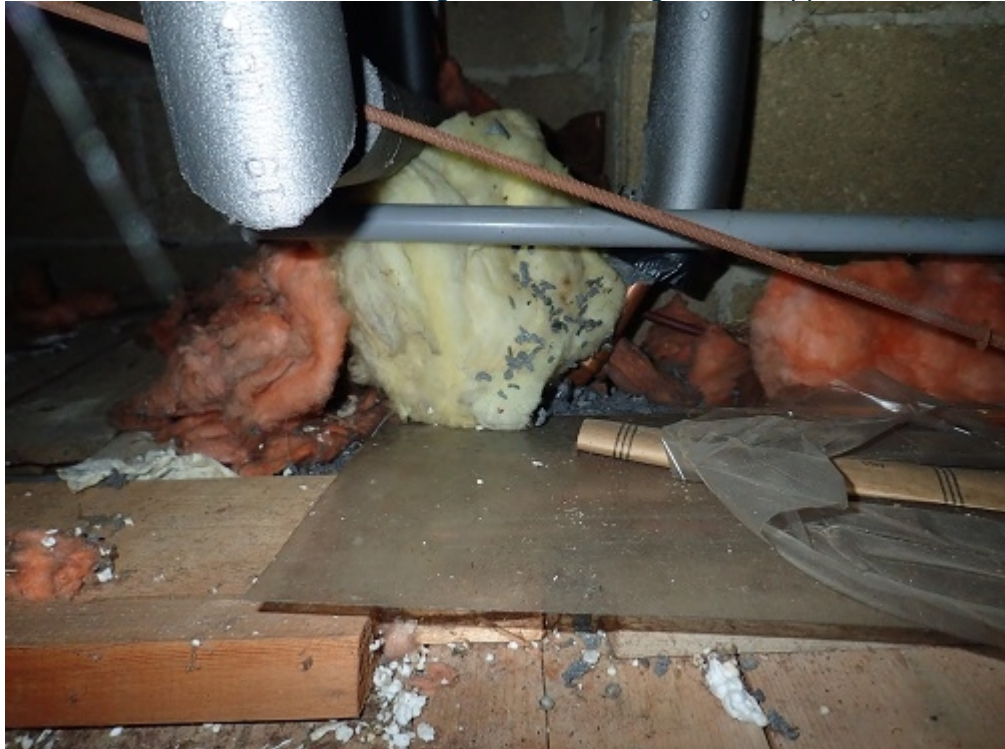
Evidence of vermin infestation was noted within the roof void. If vermin infestation persist we would recommend a specialist firm is instructed to inspect the property and eradicate vermin as required. Vermin can damage insulation and electrical wiring.

Vermin damage to roof void.

Evidence of vermin infestation as noted within the roof void. This should be eradicated as vermin can damage electrical wiring and pipe insulation.
