RICS **Building Survey**...

Example Building Survey.

| Date of the inspection | 15 May 2018 | Report reference number | Example of a Building Survey |

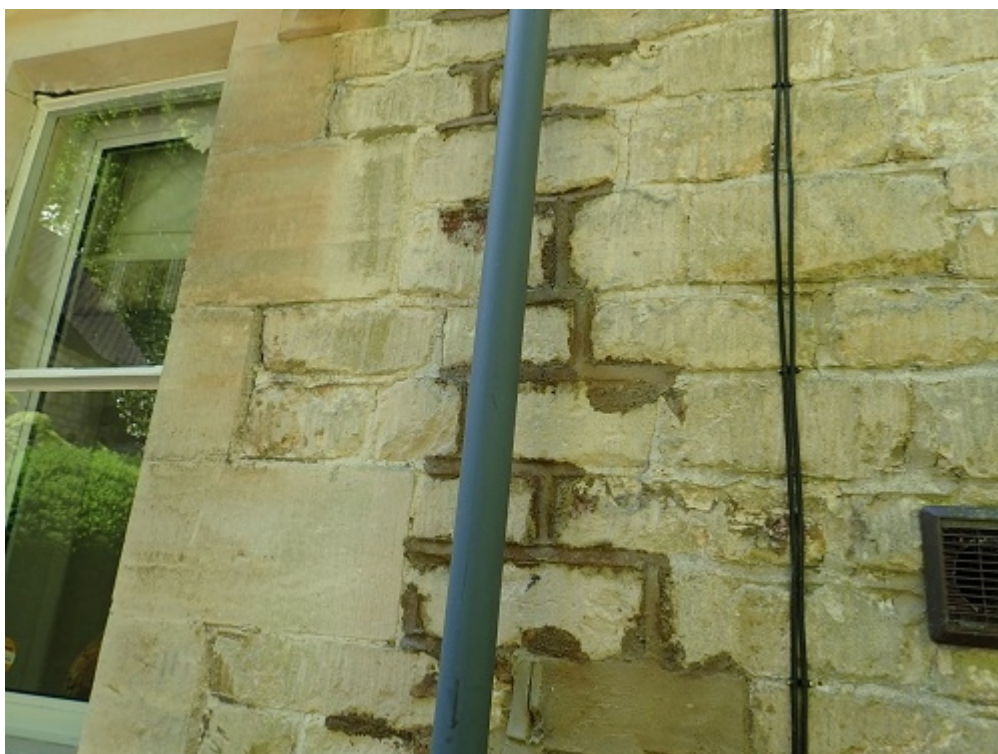
To the front elevation, the majority of wall surfaces have the original lime mortar. Lower sections of the left side wall have been repointed with darker cement mortar. Patches of cement mortar have been used to the rear elevation, particularly adjacent to the downpipe. Presumably this was in an attempt to repair past damage from previous downpipe leaks.

Non matching pointing repairs to rear wall.

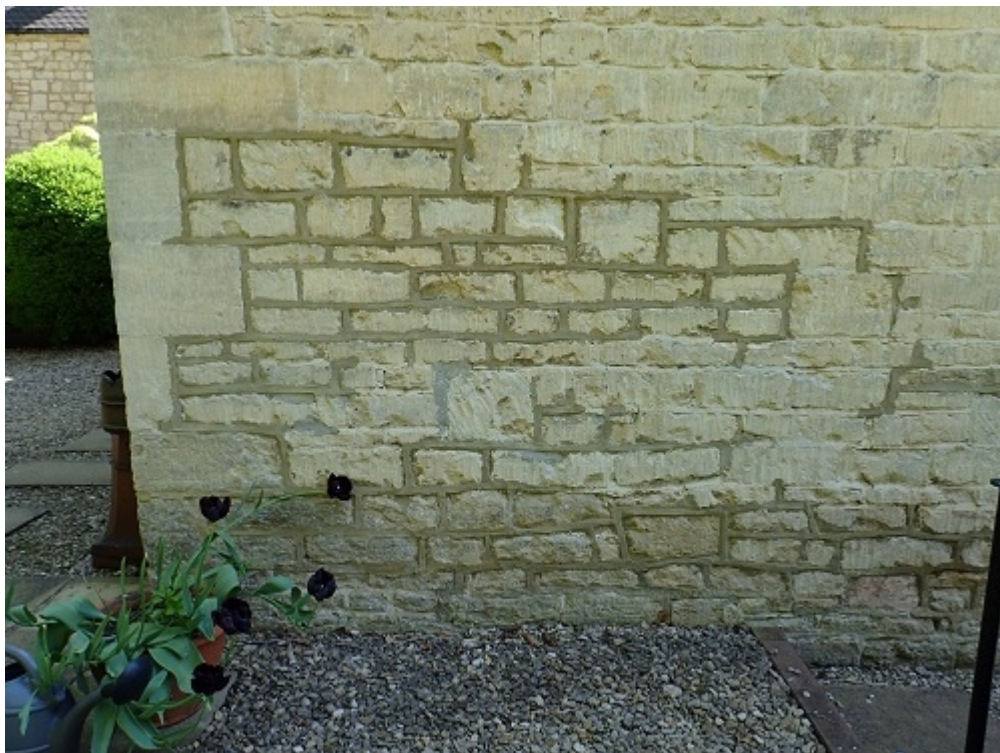
Non matching pointing repairs to rear wall.

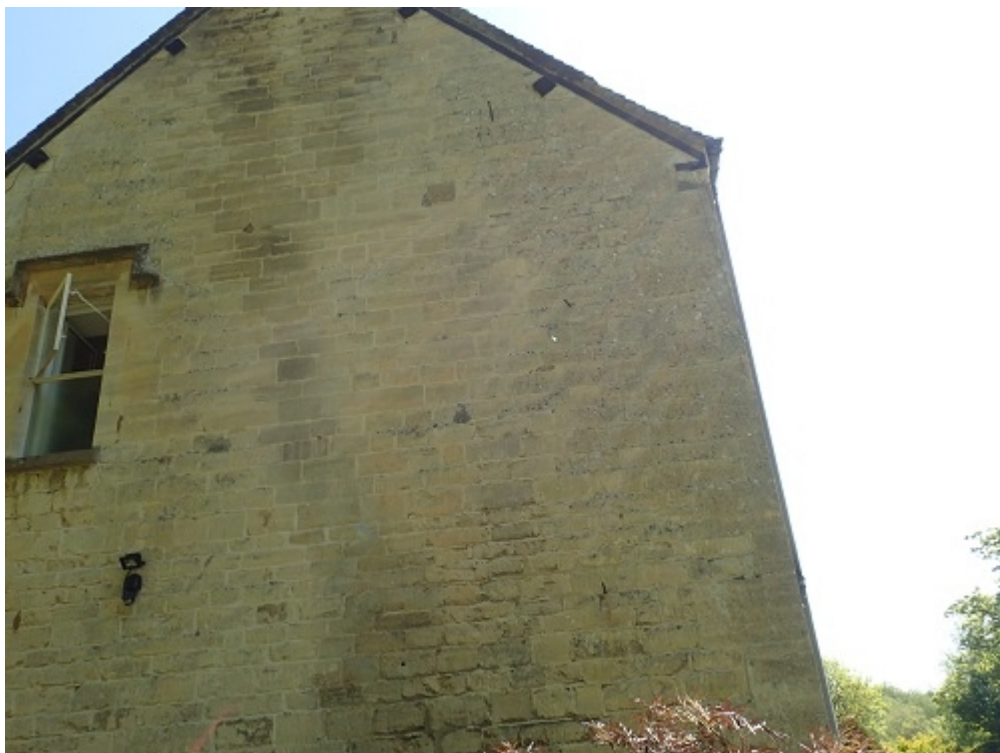
On the left side wall, dark staining was noted from the fireplace running to the chimney stack. This would indicate that the original flue liners are damaged.

Smoke staining to external surface of side wall indicates flue liner failure.

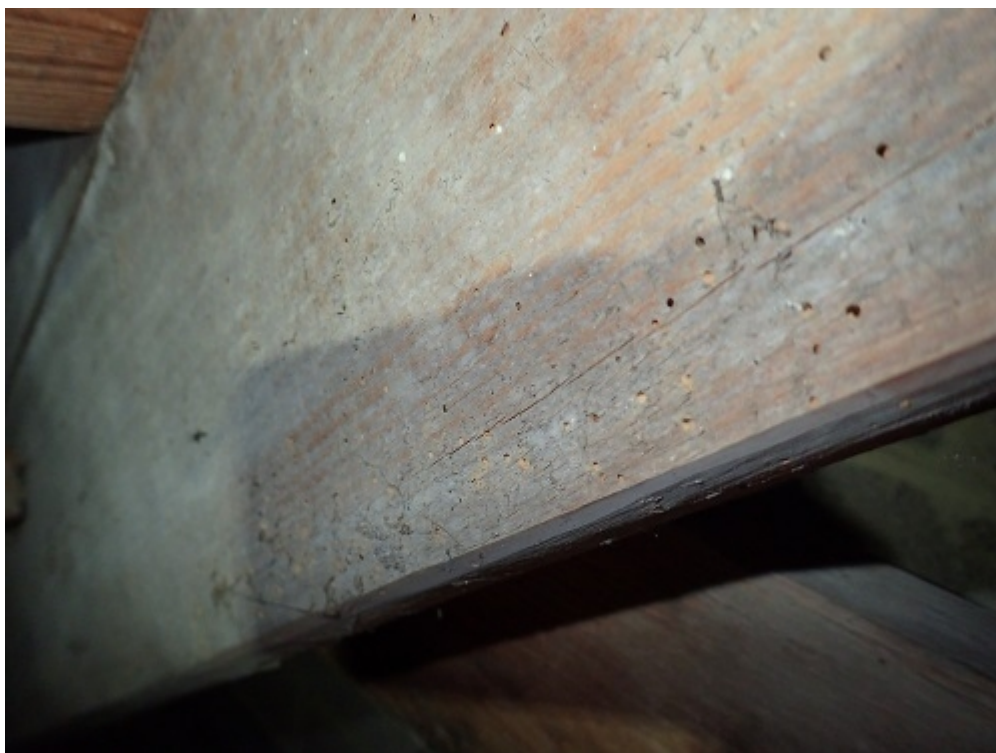
Evidence of active woodworm infestation was noted to timbers in this roof void area. Solicitors should confirm if the guarantee provided covers all internal timbers. If this is the case, the original firm issuing the guarantee should be instructed to re-inspect the property and treat active woodworm as required. If the guarantee does not cover this roof void a specialist firm should be instructed to treat active woodworm infestation. All works carried out should be provided under long term insurance backed transferable guarantee. Estimates for this work should be obtained prior to exchange of contracts.

Signs of active woodworm infestation to roof timbers.

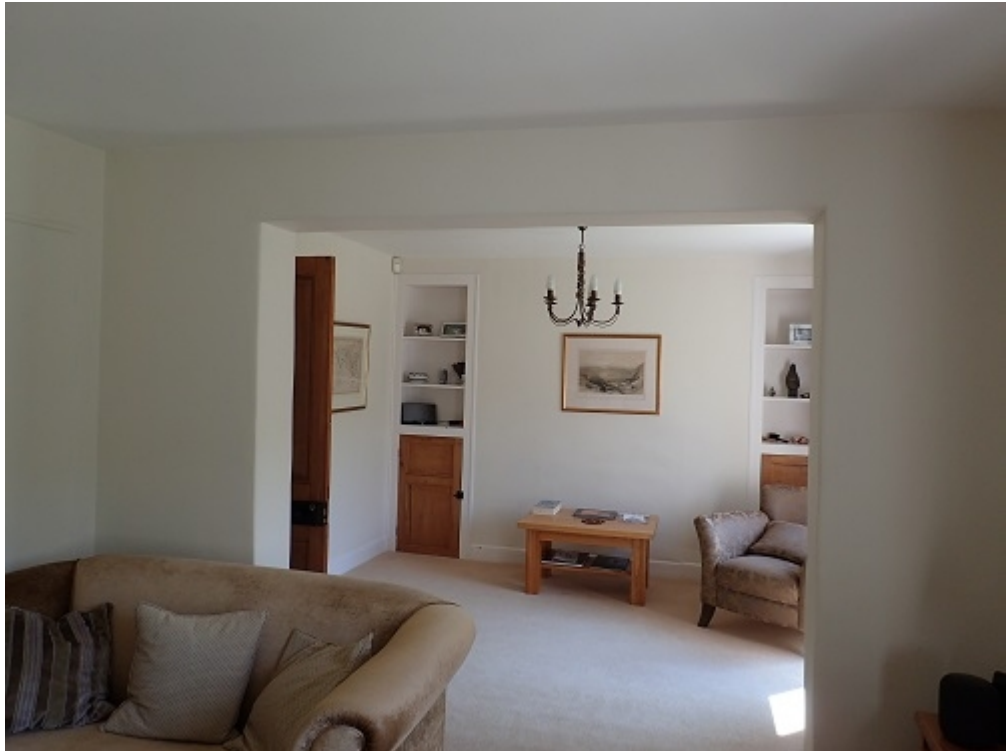
Piers to reception room are likely to offer support to a concealed lintel.

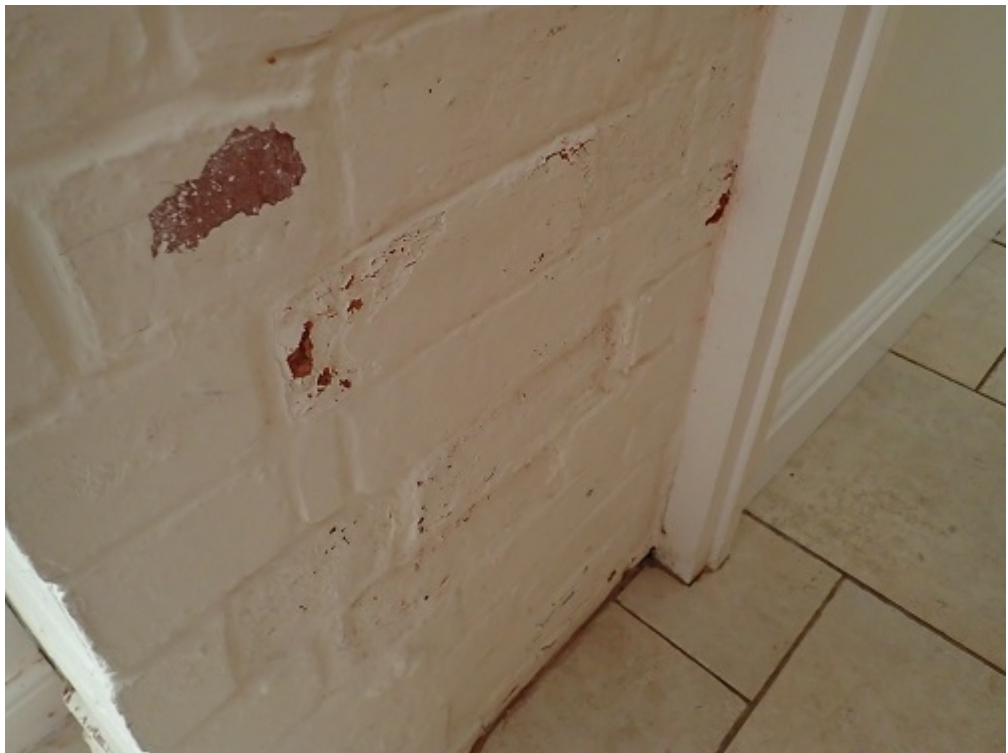
Minor damage to decorations in kitchen from dampness.

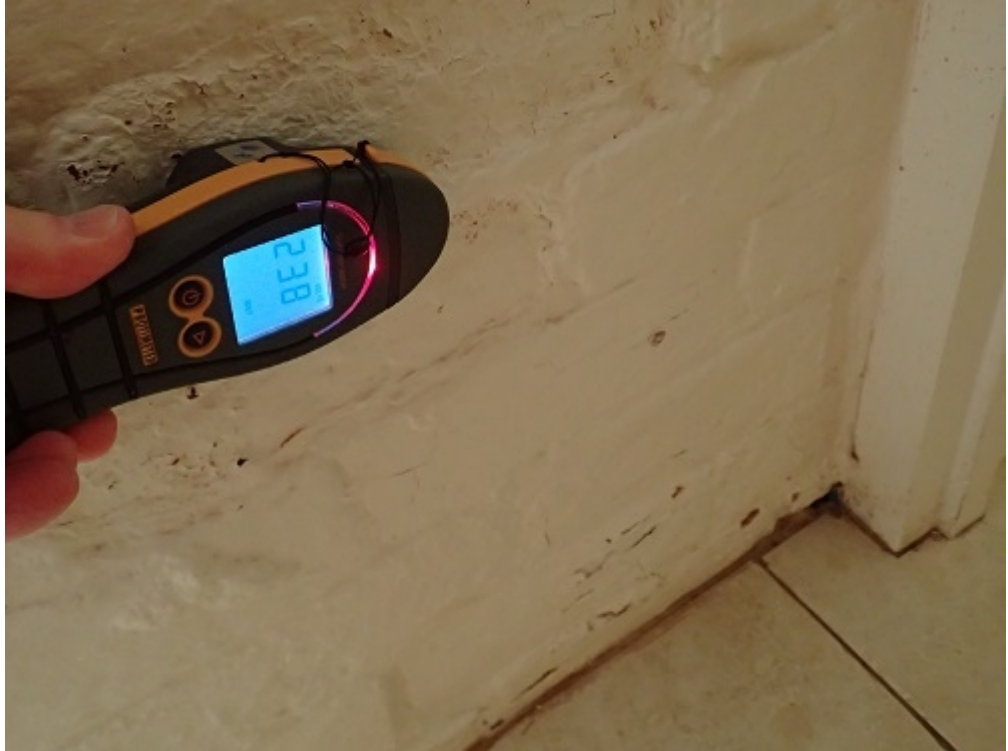
Readings were taken with an electronic damp meter at selected points throughout the property. Rising damp readings were noted to ground floor walls particularly the brick pier between the kitchen and hallway.

Damp meter readings indicates rising damp in the kitchen.

Older stone walls of this type are likely to have been built without a physical damp proof course. Various remedies are available which attempt to treat rising dampness. The most common form of damp treatment is a chemically injected damp proof course. The damp proofing of stone built houses by this method is rarely effective over the long term due to the nature of the construction. As stated above, the walls are constructed with a rubble core. Chemical injection techniques involve the injection of silicone designed to line the pores of the masonry with a substance which prevents moisture rising by capillary action. In a rubble masonry wall there is no continuous strata along which the silicone can spread and the material tends to drain freely through the rubble core. The best solution is often to manage the dampness. This will include ensuring moisture can evaporate as freely as possible from the wall surface by using the appropriate materials. Modern gypsum based plasters do not perform well in walls where the moisture content fluctuates. A traditional lime based plaster should be used and decorated with a moisture permeable decorative surface such as a water based emulsion or lime wash. Modern vinyl paints should be strictly avoided as these tend to seal the surface and prevent evaporation. An alternative solution is to mask the damp. This can be achieved by dry lining the surface with materials such as MDF cladding. Good practice would dictate that the void behind the dry lining is ventilated to remove moisture from the wall behind.

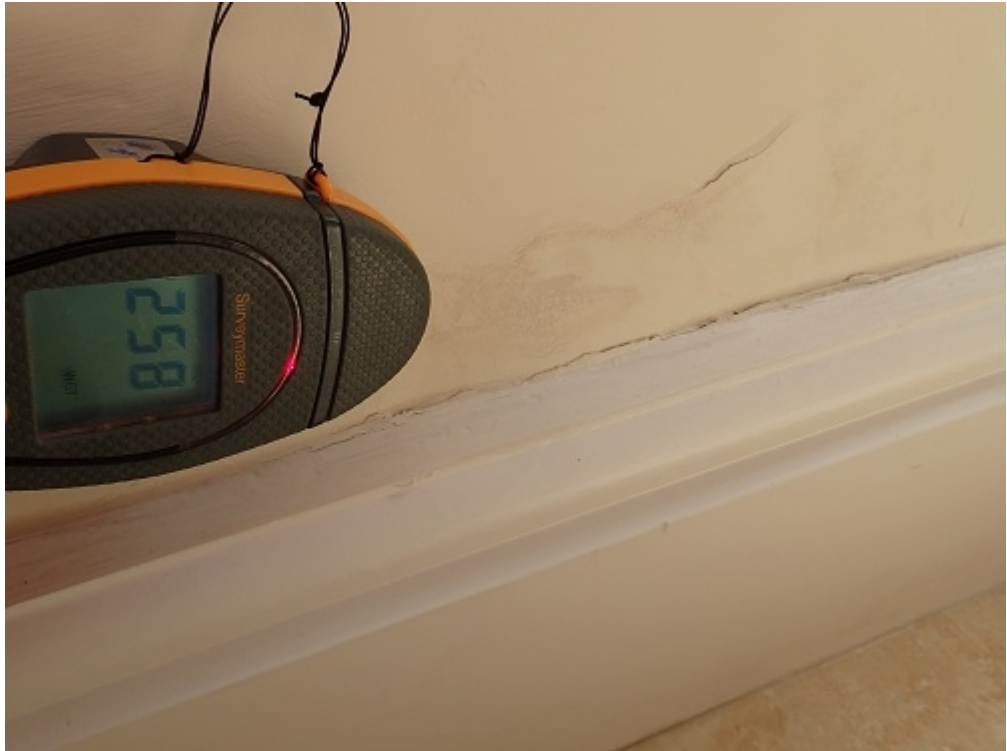
Damp meter readings indicates rising damp in the ground floor reception room.

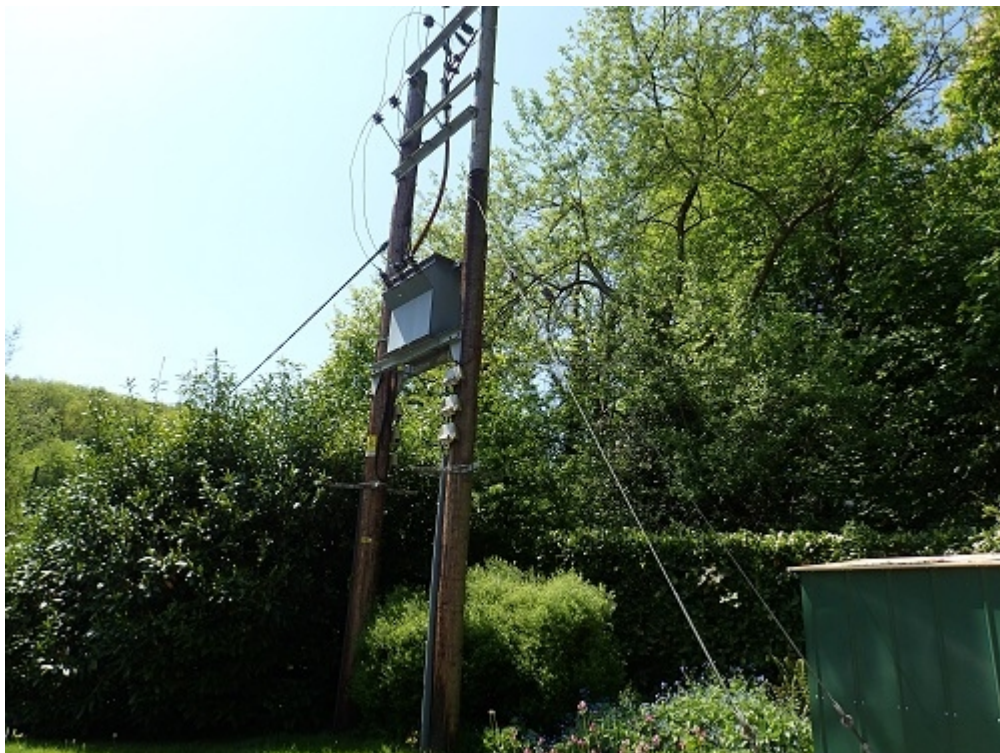
Electricity booster station in front garden.
